# WATER QUALITY FACT SHEET

## What Illegal Mining (Galamsey) Does to a River

Backed by Laboratory evidence from the Tano Offin Forest Reserve on the impact of illegal mining on water quality, aquatic life and public health — Atwima Mponua District, Ashanti Region

RESCONI . AUGUST 2026.

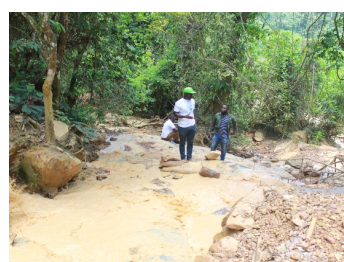
**Plate 1.** River Desiri — sediment-laden.

The two water bodies differ in one respect that matters: the land use in their immediate catchment. Ground investigation revealed intense *galamsey* activity within the floodplains along River Desiri. The Apapramasu Stream is relatively undisturbed, and was therefore selected as a control. Because the two run almost parallel through the same reserve, differences in their water chemistry can be attributed to that single variable rather than to rainfall, geology or season.

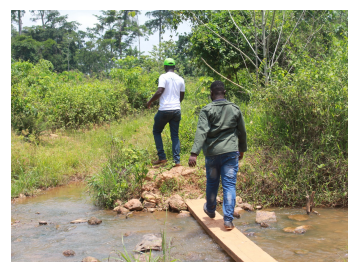
**Plate 3.** Apapramasu — the control.
